Inspected for: Property Owner

# Springfield, Oregon Date: 11/6th & 7th/2014

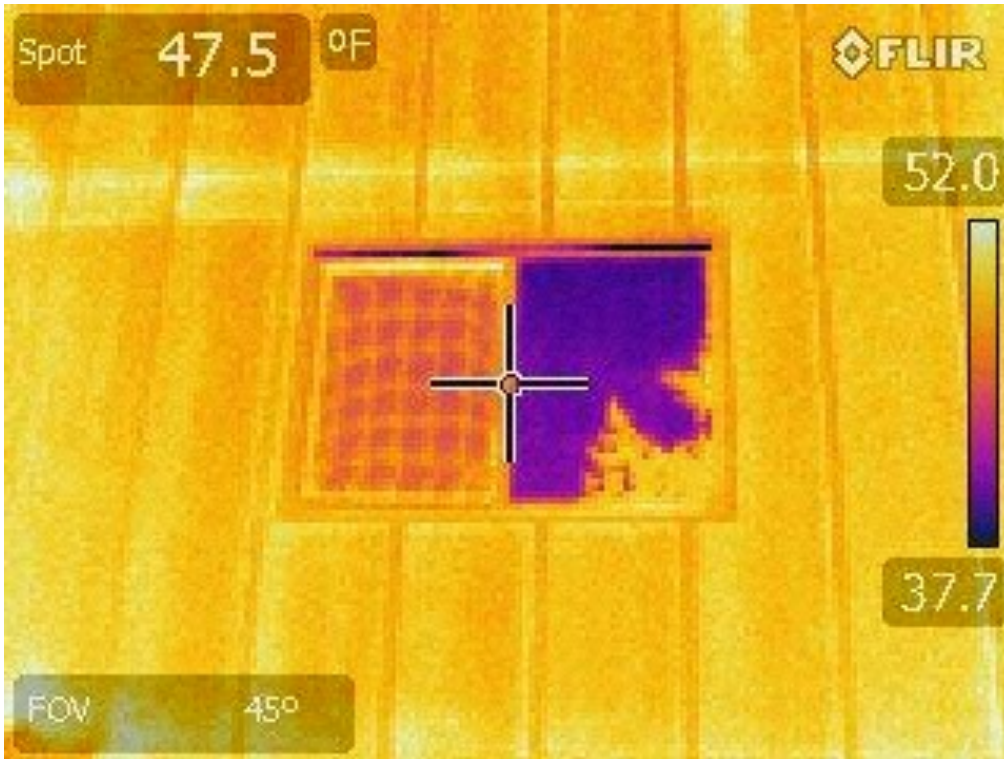
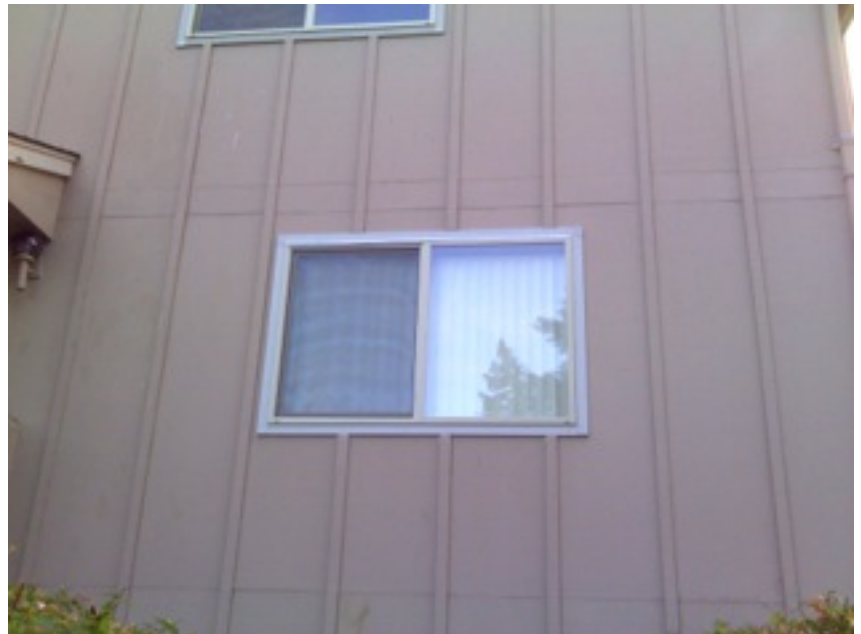
**LOCATION:** Exterior wall, north facing.  
**EQUIPMENT:** Exterior window  
**NOTE:** No thermal signature noted that suggested water intrusion around the window assembly.

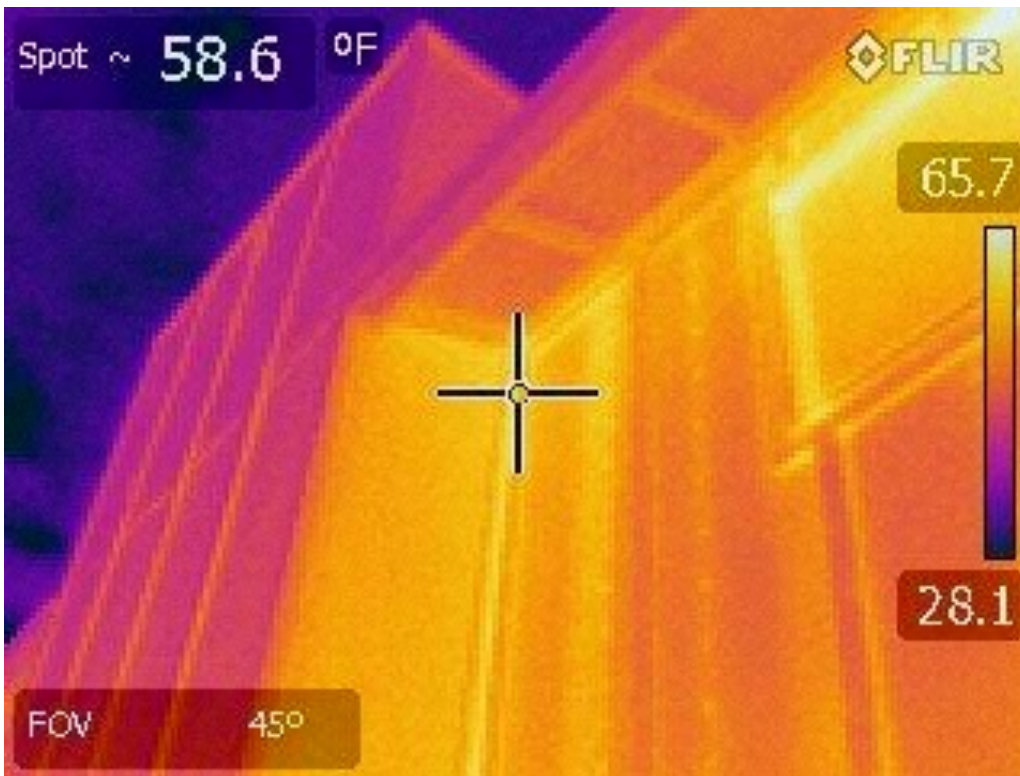
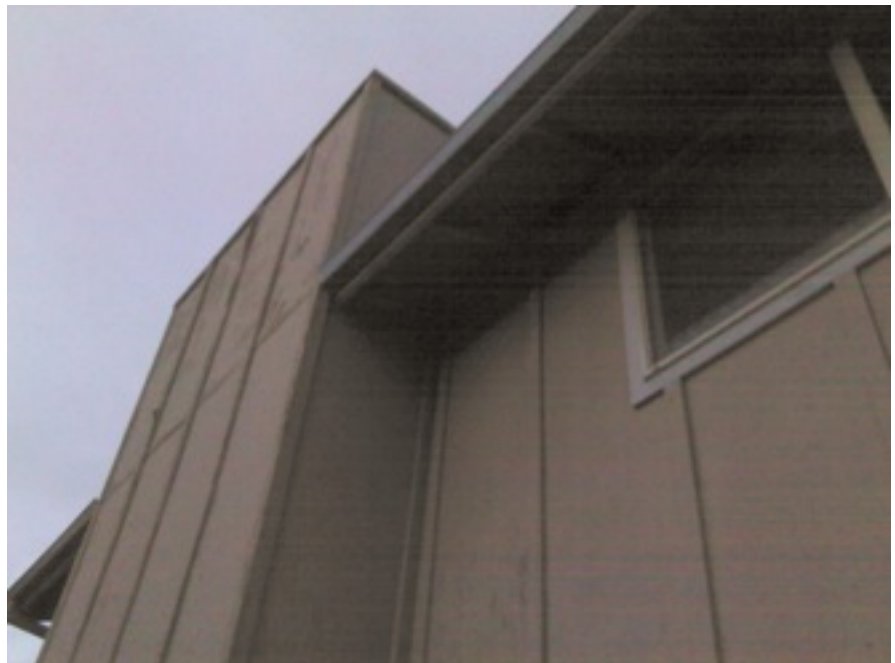
**LOCATION:** Exterior wall, west facing.  
**EQUIPMENT:** Chimney Chase.  
**NOTE:** No thermal signature noted that suggested water intrusion around the chimney chase.

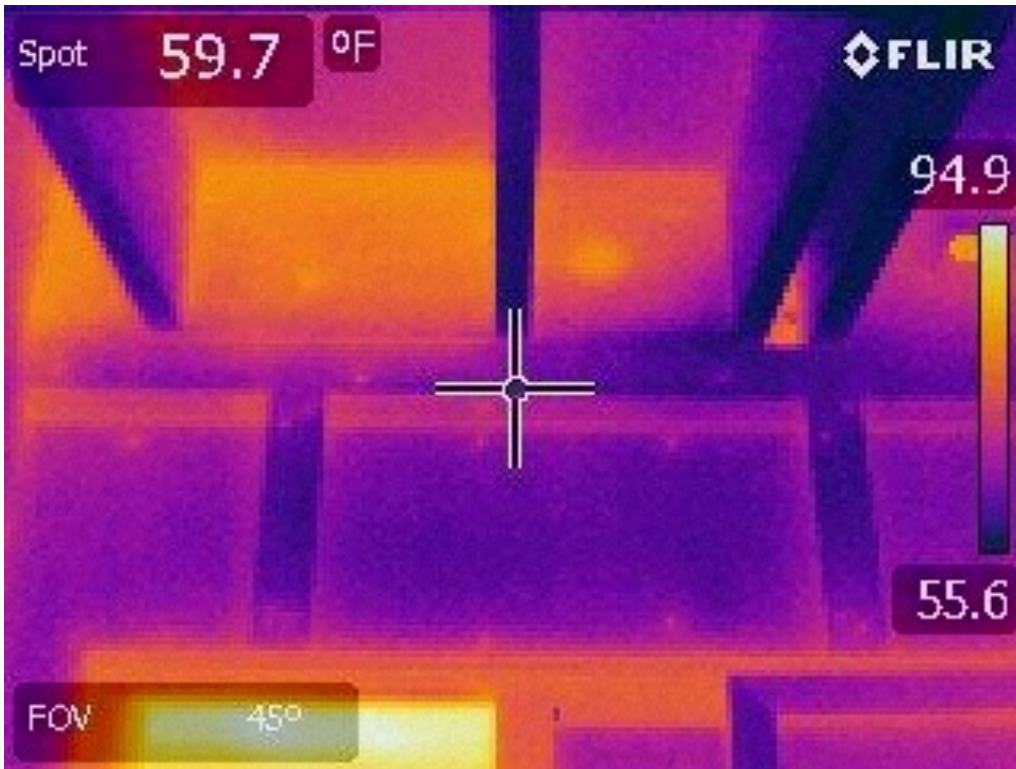
**LOCATION:** Exterior wall, west facing  
**EQUIPMENT:** Rear deck attachment to attachment to house  
**NOTE:** No thermal signature noted that suggested water intrusion around the attachment to the house.

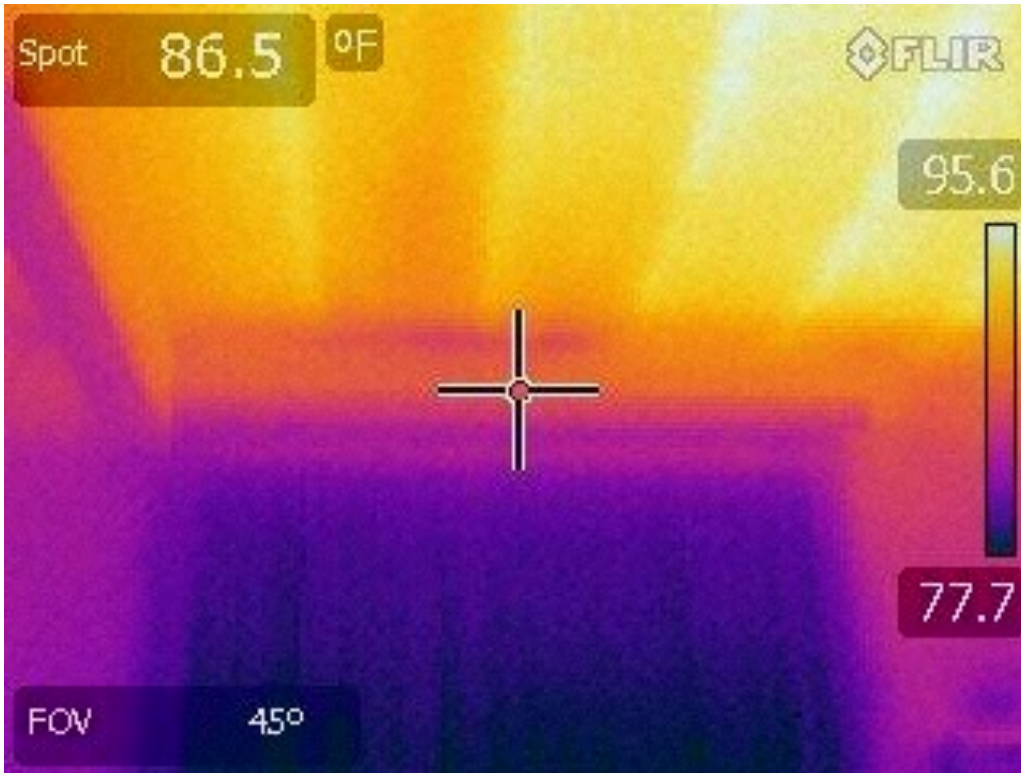
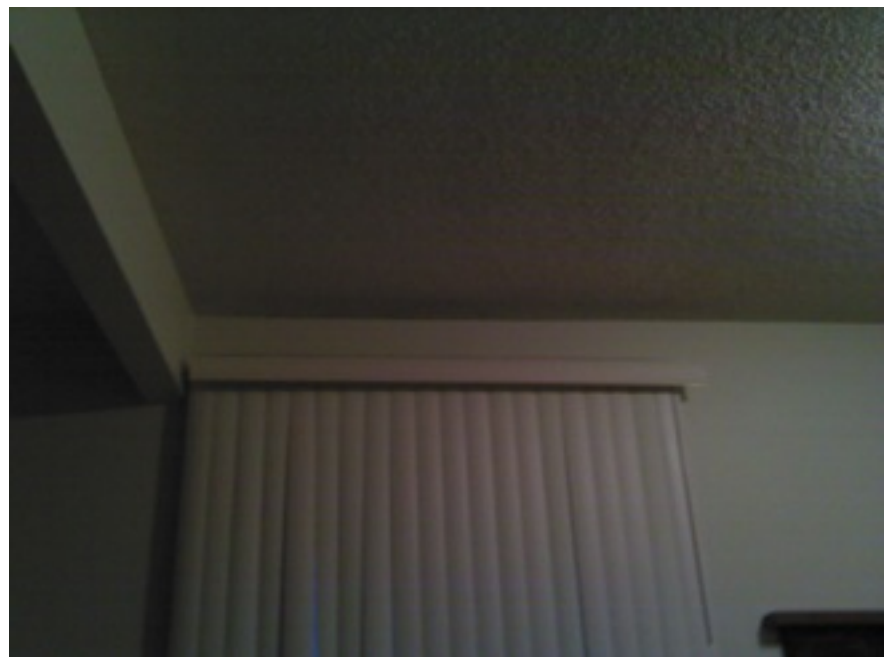
**LOCATION:** Downstairs at sliding glass door.  
**EQUIPMENT:** Ceiling where the deck attaches to exterior of the home.  
**NOTE:** No thermal signature noted that suggested water intrusion around the attachment to the house.

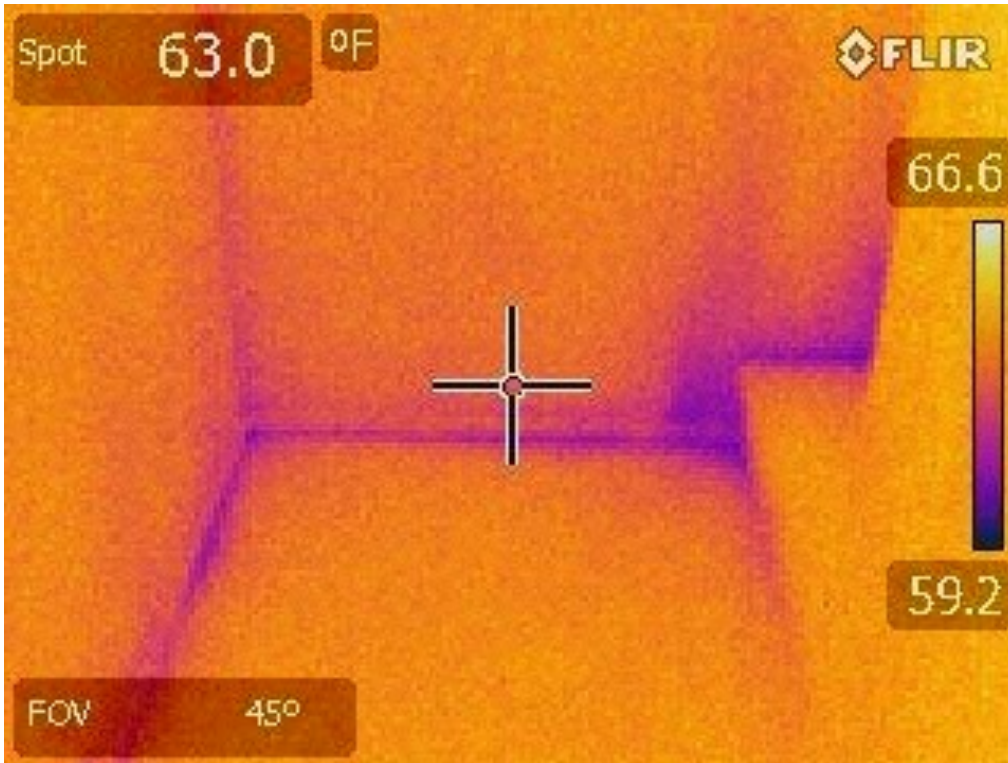
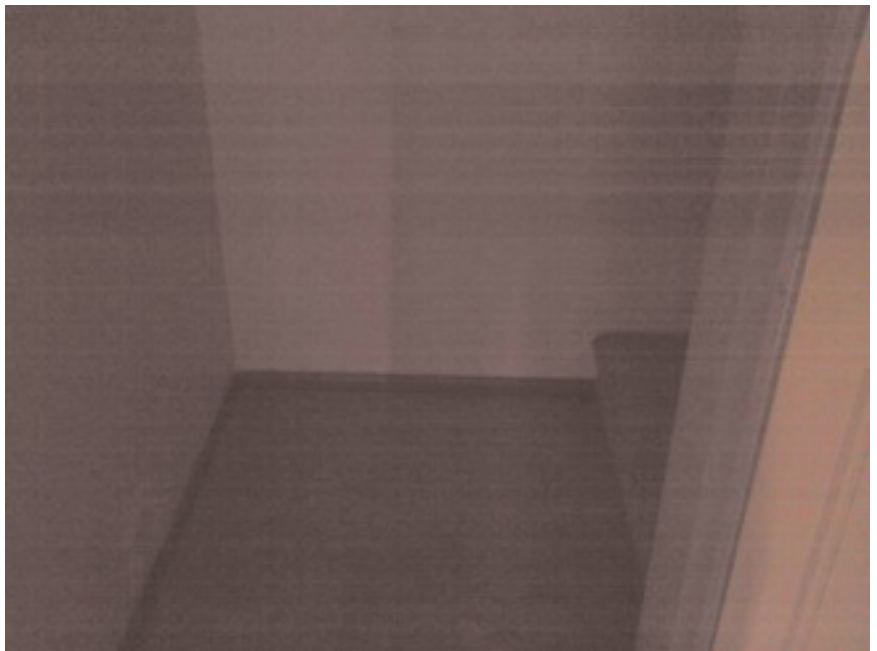
**LOCATION:** Downstairs at bottom of stairway.  
**EQUIPMENT:** Interior wall  
**NOTE:** No thermal signature noted that suggested water intrusion around the attachment to the house.

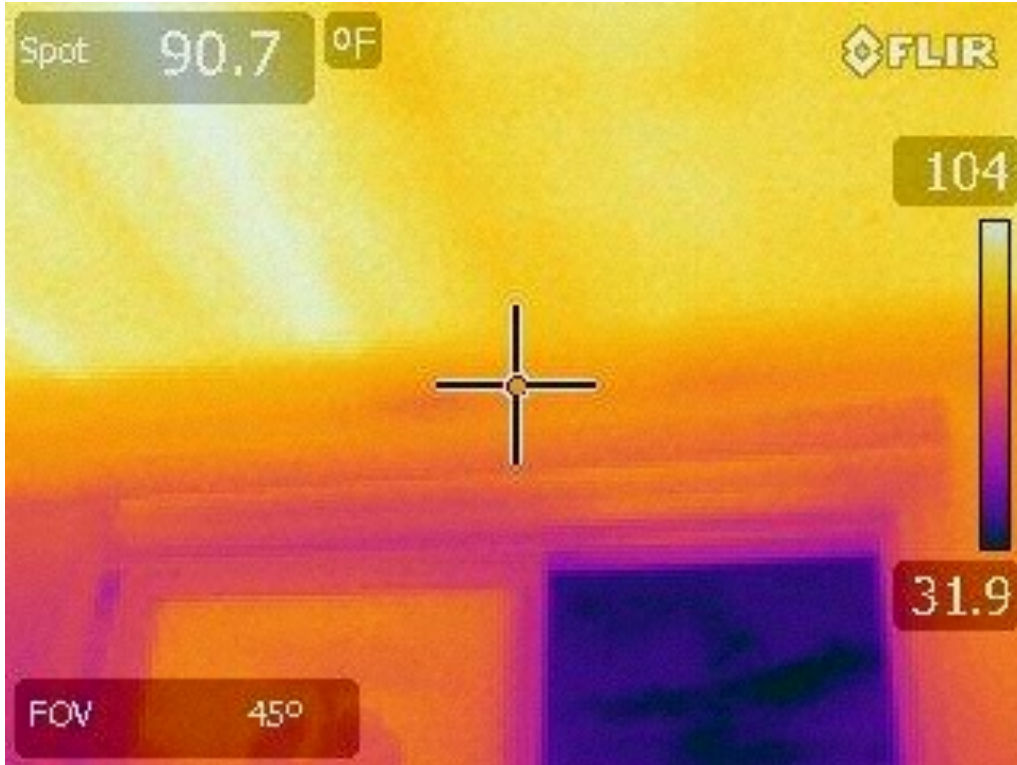
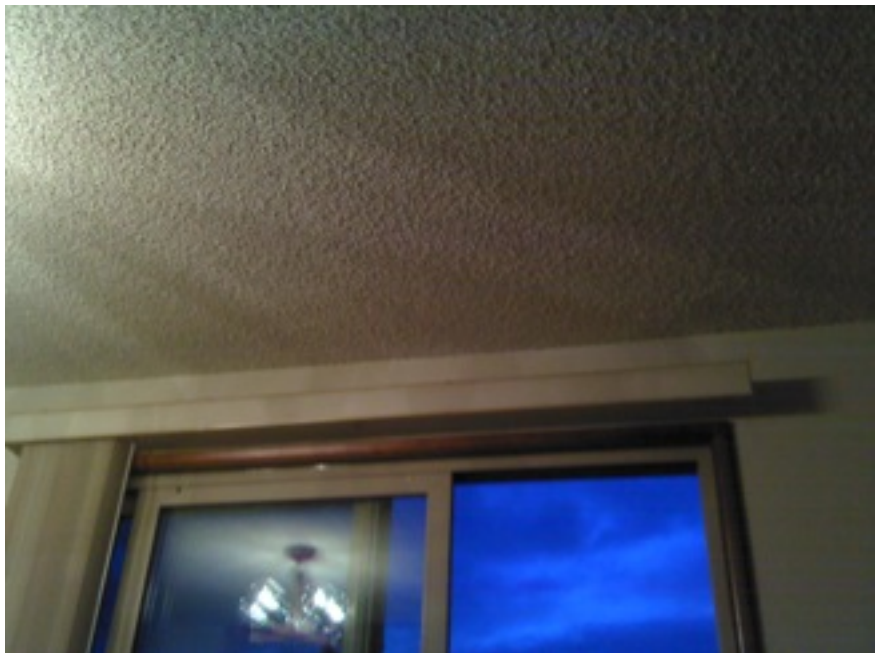
**LOCATION:** Main floor.  
**EQUIPMENT:** Ceiling over sliding glass door.  
**NOTE:** Thermal signature corresponding with stains on ceiling appear to be from exhaust vents in ceiling. Inspector thinks stains could be from deteriorating sealant on exterior of building where exhaust vents terminate. Condensation from uninsulated exhaust ducts may also be contributing to stains on ceiling.

MEASUREMENTS	
Spot 1	171
Spot 2	155
Spot 3	
Spot 4

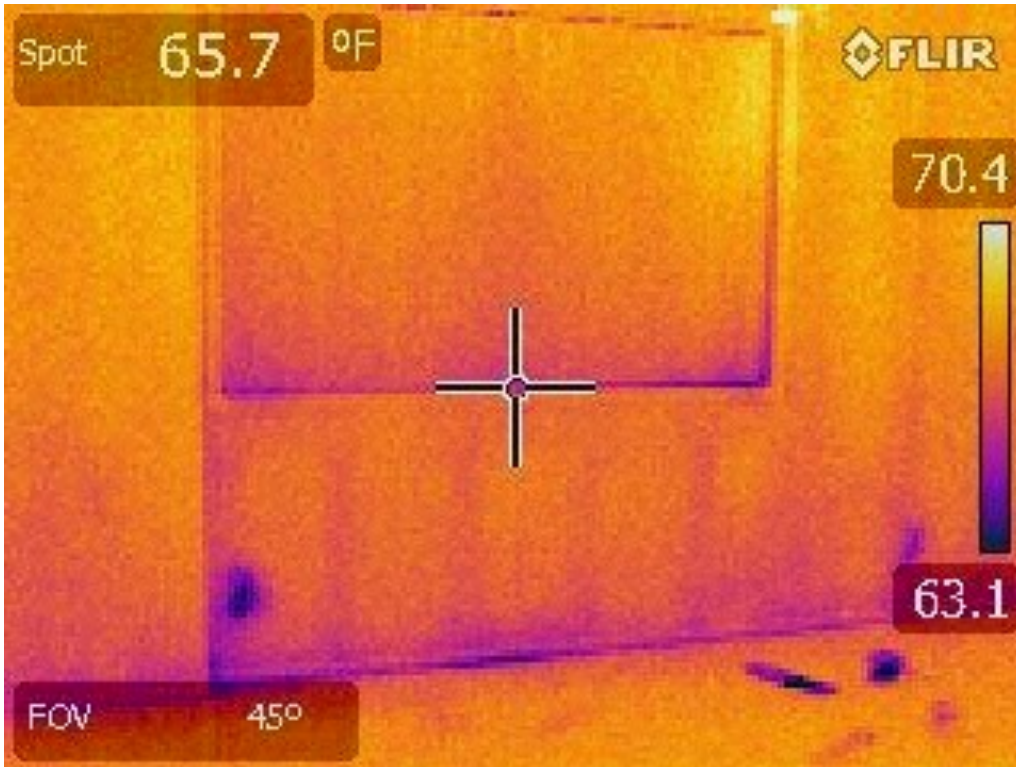
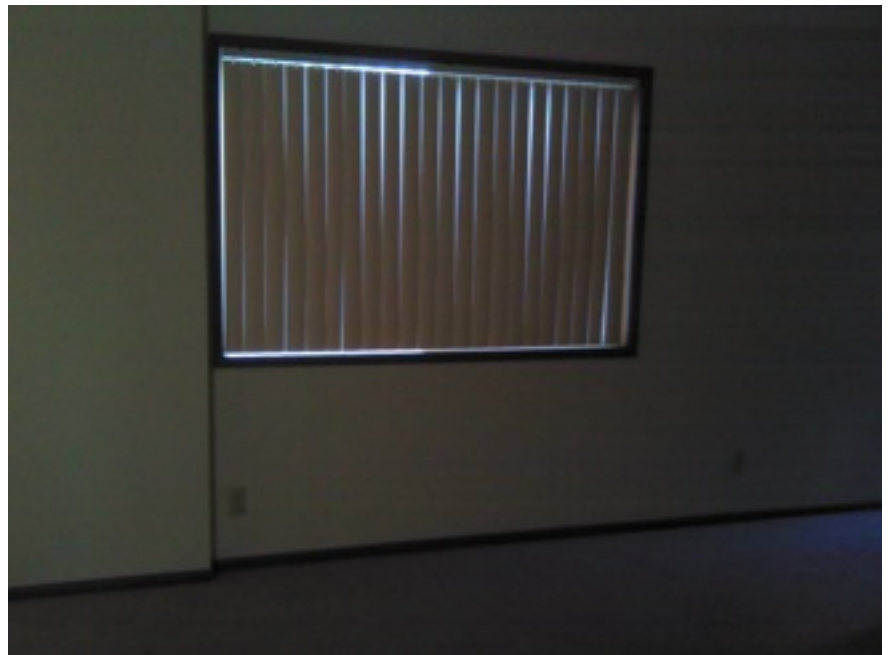
**LOCATION:** Main floor, north facing.

**EQUIPMENT:** Window assembly and interior wall.

**NOTE:** No thermal signature noted that suggested water intrusion around the window assembly.

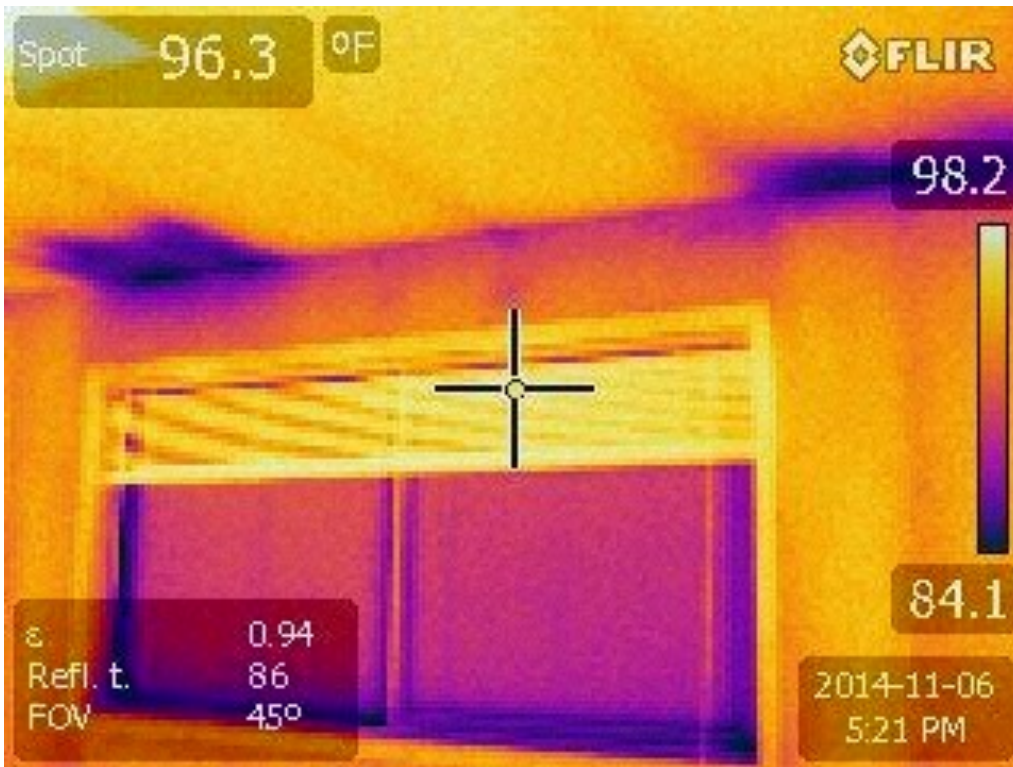
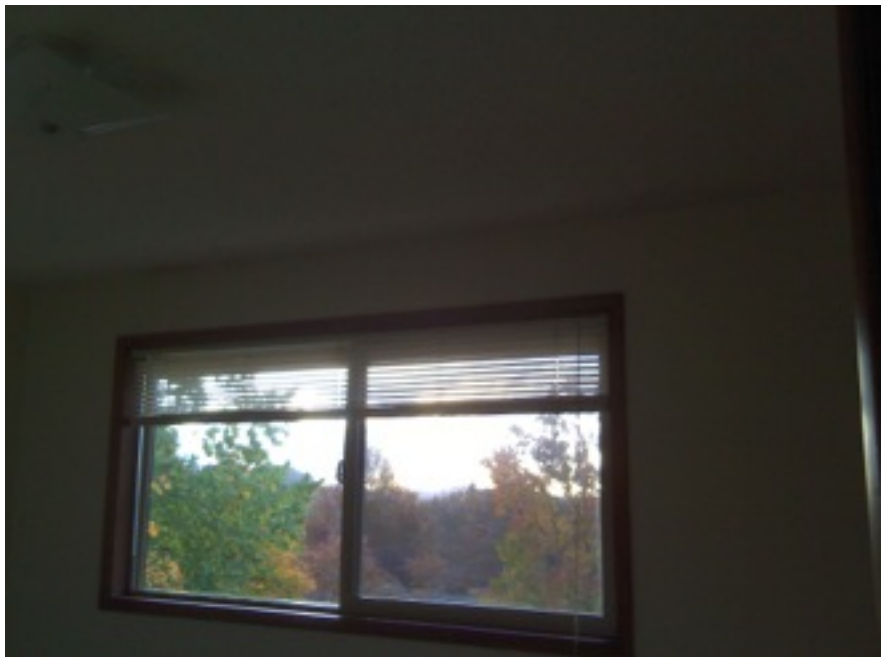
**LOCATION:** Upstairs west facing bedroom.

**EQUIPMENT:** Window assembly and interior walls and ceiling

**NOTE:** Thermal signatures on ceiling appear to be from cold air intrusion at soffit vents. Thermal signatures correspond to the location of the stains on the ceiling. No elevated moisture levels at time of inspection.
