THE INSPECTION REPORT

Oregon Street

Oregon Street, Eugene, OR 97405
Inspection prepared for: Luke Rabun
Date of Inspection: 1/31/2018 Time: 9:00
Age of Home: 1970 Size: 1280
Weather: Clouds

WOOD DESTROYING ORGANISMS

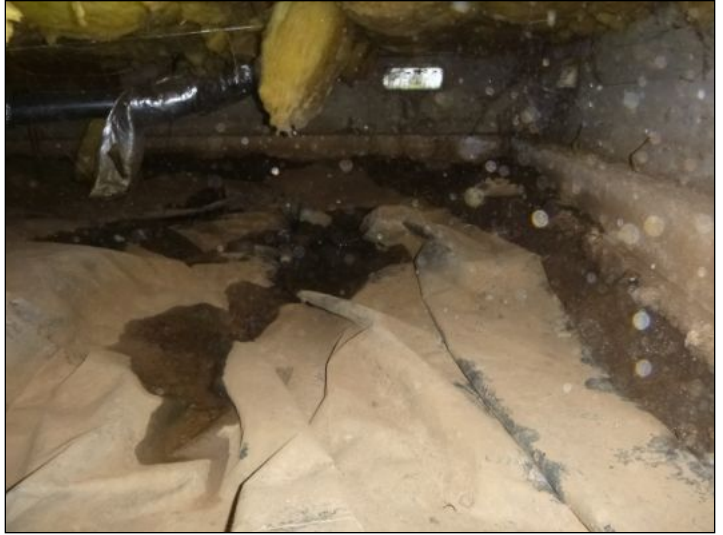
Pooling water in crawlspace.

Water pooled in the crawlspace at the time of the inspection. This condition can result in wood rot and pest infestations. Inspector recommends correction by a qualified contractor.

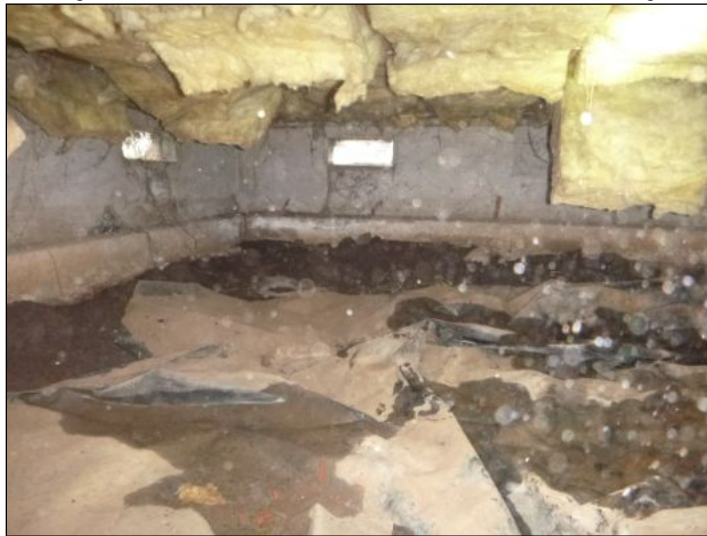
Pooling water in crawlspace. Displaced vapor barrier.

Vapor barrier is missing or has been displaced and no longer covers the soil in spots. This condition can result in wood rot and pest infestations. The floor of the crawlspace was covered with a vapor barrier in some areas. Recommended correction by a qualified contractor.
